POWER SYSTEMS, INC.

PRODUCT INFORMATION BULLETIN

DATE: January 2001

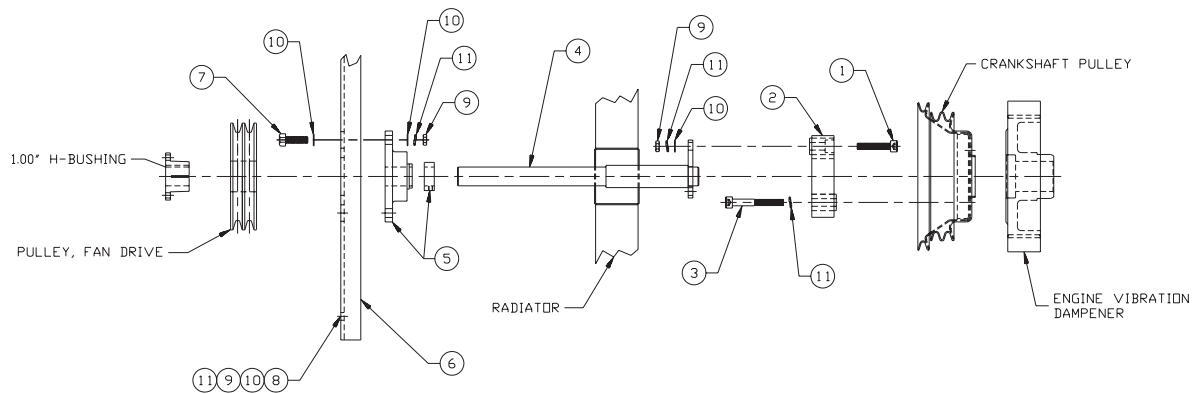
SUBJECT: 7.4L Flange, Flex Drive Coupling Replacement

MODELS AFFECTED: 85 & 100 kW gearbox driven units with 7.4L engines (pre April 2001).

CORRECTIVE ACTION: When replacing the coupling assembly use kit number #**D4328**. This kit should be used on product built prior to April 2001.

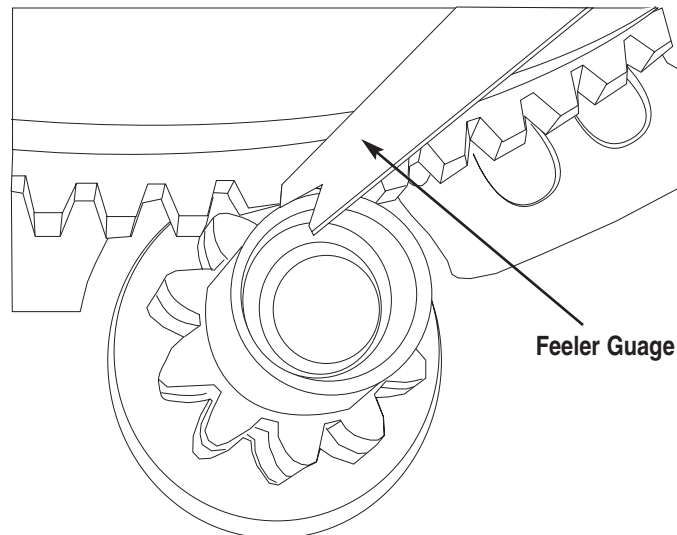
PROBLEM: Starter pinion jammed into flywheel on initial cranking.

Check for proper position of rectangular rubber bumper part number 0C3794. Older units used rubber dimples, they should be replaced if jamming is occurring. New rubber bumper gets placed at base of block right above sump cover, and on the centerline of the starter.

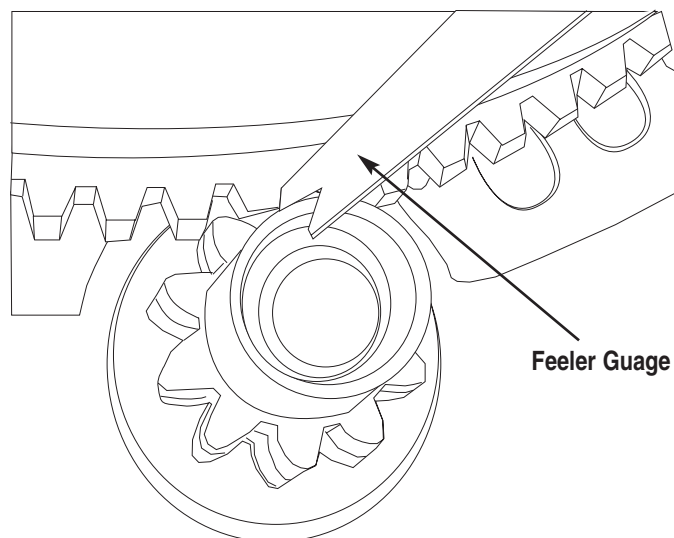
- DATE:** September 2001
- SUBJECT:** GV220 Starters
- MODELS AFFECTED:** 802-3, 803-4, 940-0, 940-1, 941-0, 941-1, 463-3, 498-1, 584-3
All models with a date code higher than 03220 are not affected.
- PROBLEM:** Starter pinion jammed into flywheel on initial cranking.
- CORRECTIVE ACTION:** Measure the voltage at the terminal of the starter contactor and verify 11-12 volts DC is available to the generator during cranking. If voltage is below 11 volts DC, measure at the battery terminals during cranking. If battery voltage is below 11 volts DC, recharge/replace battery. If battery voltage is above 11 volts DC, check for proper battery cable sizing, see owners manual.

Manually engage the starter pinion into to ring gear on the flywheel and check for .020-.035 inch backlash. When checking backlash, measure at eight equally spaced locations and make sure the gear teeth are in contact in the direction of rotation. Shim or remove shims as necessary, use shim kit part number 0D4983. Shim thickness is .202 inch, two or three shims should be ordered. Shims should be placed on the left side starter bolt hole, opposite of stepper motor bracket. Visually check that the starter motor is perpendicular to the ring gear. Replace the starter motor if the starter motor mounting bracket is bent.

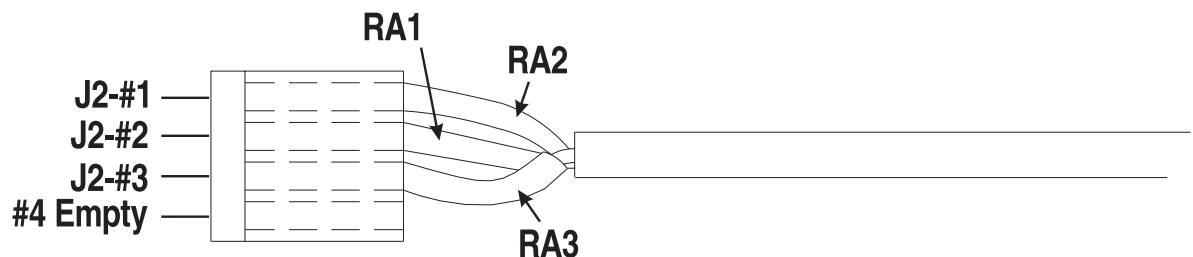
- DATE: July 2001
- SUBJECT: D Panel Wiring
- MODELS AFFECTED: D Panel, standby units with 20 Light Remote Annunciator or Remote Relay Panel (s)
- PROBLEM: The 20 Light Remote Annunciator or Remote Relay Panel does not communicate with the D panel and the RS 485 connections and wiring is correct and tests O.K..
- CORRECTIVE ACTION: Check that the J2 plug in the D panel is wired correctly.
1. Remove fuse.
 2. Lift the top, and lower the face of the D panel.
 3. Locate the J2 connection on the top right side of the panel.
 4. Confirm that the wiring is correct (J2 - #1 starts at the "bottom"):
 - a. Wire RA2 to J2 - #1
 - b. Wire RA1 to J2 - #2
 - c. Wire RA3 to J2 - #3
5. Rewire if incorrect.
 6. Close and fasten panel.
 7. Replace fuse.
 8. Check operation of 20 Light Remote Annunciator or Remote Relay Panel(s).

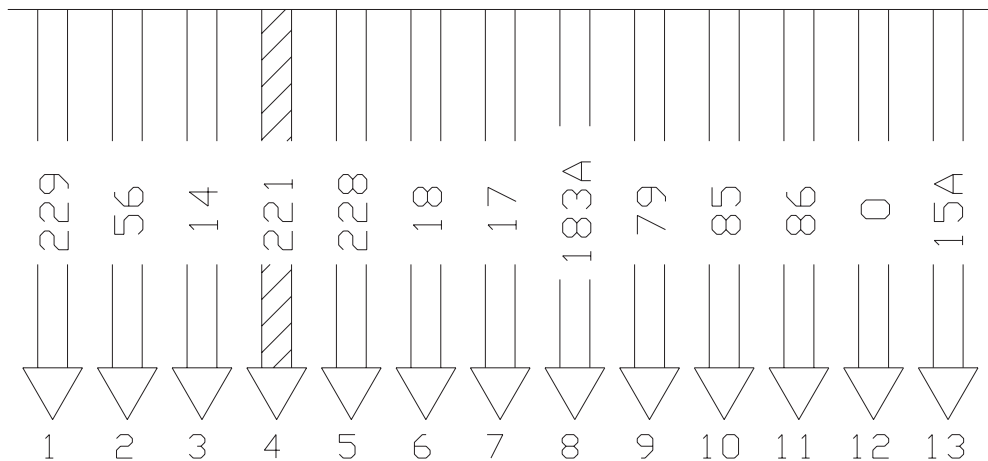
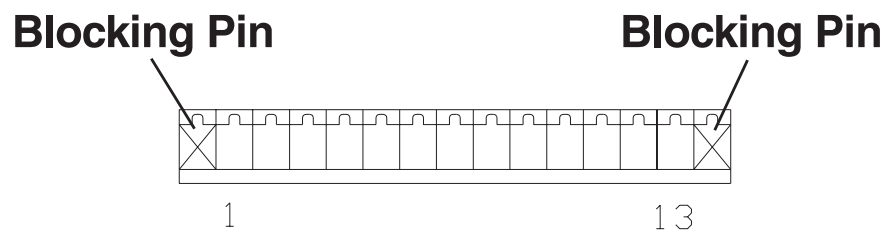
PROBLEM: The J2 plug that connects to the #083089 C Option PCB may have the Blocking Pins (or Keys/Plugs) missing from the ends of the plug. The Blocking Pins prevent the connector plug from being misaligned with the PCB pins.

CAUTION! Failure to properly match up the plug can result in damage to the PCB.

CORRECTIVE ACTION: Take care when removing and reinstalling the connector. Make sure the pins are properly aligned. When properly aligned, there will be an empty plug on each end. The part number for the Blocking Pin is #078696.
