# **GENERAC**<sup>®</sup>

**P**RODUCT **I**NFORMATION **B**ULLETINS,

**P**ARTS **U**PDATE **B**ULLETINS &

**W**ARRANTY **I**NFORMATION **B**ULLETINS

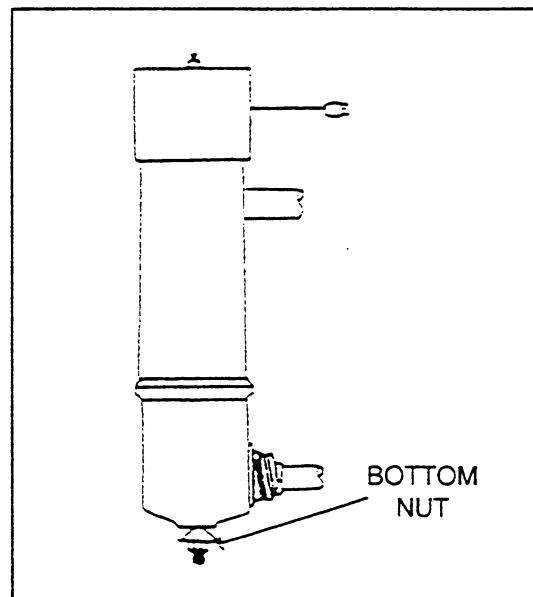
SUBJECT: Possible block heater leaks.

CORRECTIVE ACTION: The manufacturer of the 1000 watt block heater (P.N. 66034A) and the 1500 watt block heater (P.N. 66034C) ha recommended that these heaters be retorqued during the startup procedure.

- 1) Start the generator and allow ten minutes for warm-up.
- 2) After the ten minute warm-up period, shut the generator down. Torque the bottom nut to 6 (six) foot-pounds. (See Figure 1 below).

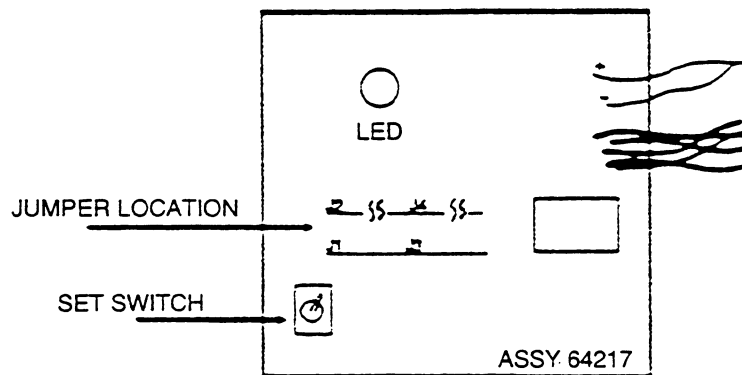
NOTE: Failure to cut the appropriate jumpers will result in disruption or failure of the normal exercise cycle.

- 1) For a 60 Hertz system, cut jumpers J2 and J4, as shown below.

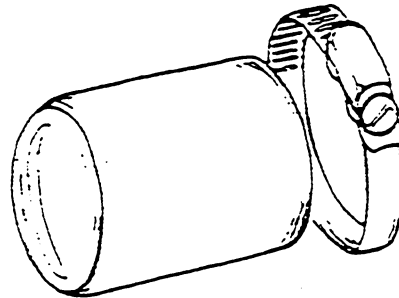
PROBLEM: Extreme temperature conditions or direct sunlight may reduce the life of the coolant outlet cap on these units. A neoprene cap (Part No. 69943) is now available from Generac for use in extreme conditions.

CORRECTIVE ACTION: During next scheduled maintenance, please inspect the coolant outlet cap (located in the rear of the engine, just left of the intake manifold). If cap feels brittle, has fine surface cracks, or appears wet, replace it with Part No. 69943.

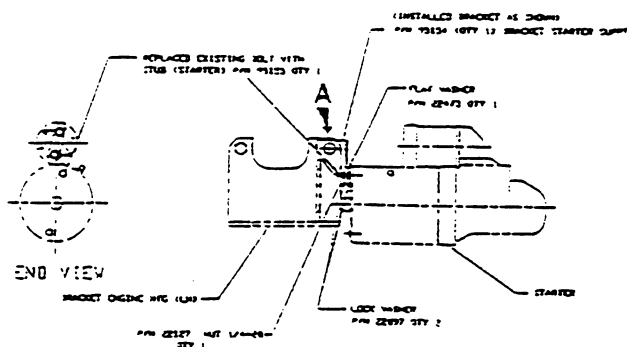
PROBLEM: Starter shifts slightly during cranking which may cause damage to the flywheel and/or starter (units prior to September 1994 may have this problem).

1. Remove starter from set.
2. Replace top stud with part number 95155 (see illustration).
3. Remove motor mount bolt "A". Warning: Before removing this motor mount bolt, you must support the engine. It may drop slightly if not supported.
4. Install bracket part number 95154 and re-install motor mount bolt "A".
5. Install 1 each. lock washer part number 22097 then 1 each. flat washer part number 22473 on new starter motor stud and re-install starter.
6. Put 1 each. lock washer part number 22097 on new starter stud and 1 each. nut part number 22127 and tighten. This will secure the back of the starter to the bracket/starter support.

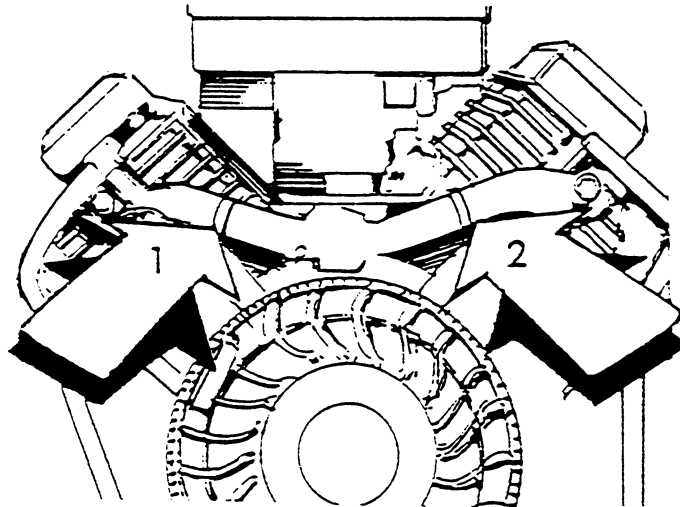
FIG. A

PROBLEM: The ignition module wire must be tie-wrapped to the intake manifold (Fig A, Item 1 & 2). If not properly tie-wrapped it may cause the wire to make contact with the cylinder resulting in a melted coating of the wire and possibly shorting the wire causing no or intermediate spark from that module.

CORRECTIVE ACTION: Repair or replace wire (shrink tubing can be used). Add tie-wrap (Fig. A, item 1 & 2) to wire #18 and manifold to prevent wire from contacting cylinder. If problem persists check ignition shorting diodes for short.

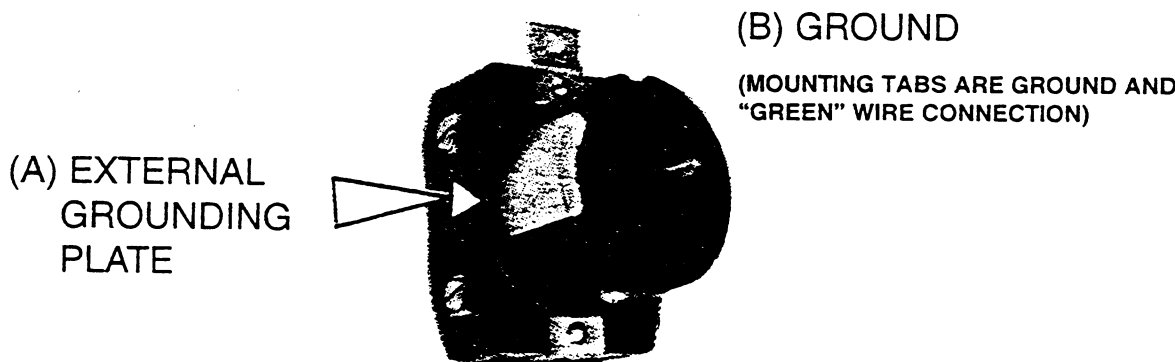
FIGURE 1

**CAUTION:** This condition could be dangerous if a shorted circuit to ground should occur, even though the generator is properly grounded.

**CORRECTIVE ACTION:** With a multi meter set on the RX1 scale make a continuity check between the plate on receptacle ("A") and the mounting screws for the receptacle (Generator ground). There should be a reading between the two. If there is no reading replace the receptacle immediately (Part # 79486) DO NOT ALLOW THE USAGE OF THE DAMAGED RECEPTACLE.

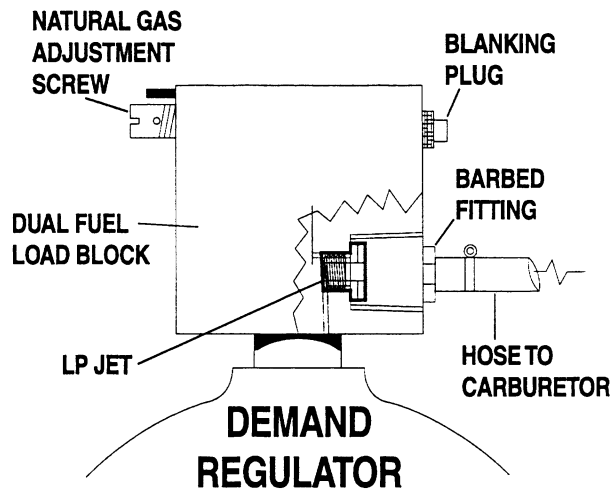
SYMPTOMS: Hard starting, runs rough, and unable to carry load when running on LP fuel supply. **Units running on natural gas will not have this problem.**

CORRECTIVE ACTION: Replace the LP jet in the fuel load block. Order an LP Jet Kit, Part #A9083K through your normal source of Generac parts. The kit includes the jet and installation instructions.

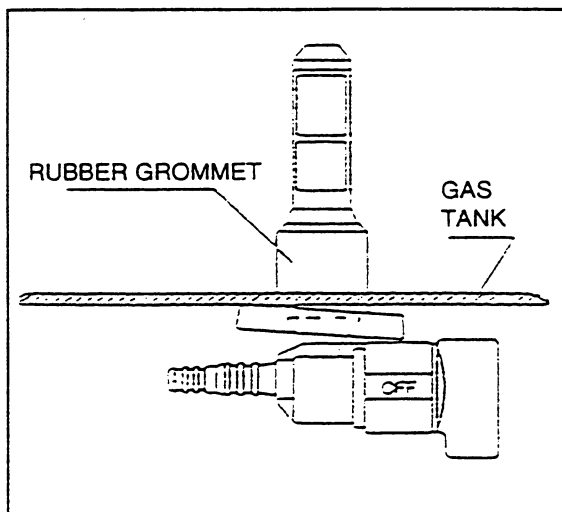
FIGURE 1

**PROBLEM:** Over insertion of the fuel shut-off valve into the rubber grommet can cause elongation of the fuel outlet on the tank. The fuel shut-off valve has a stop built into it, but we have seen the fuel shut-off valve pushed beyond the stop (Figure 1).

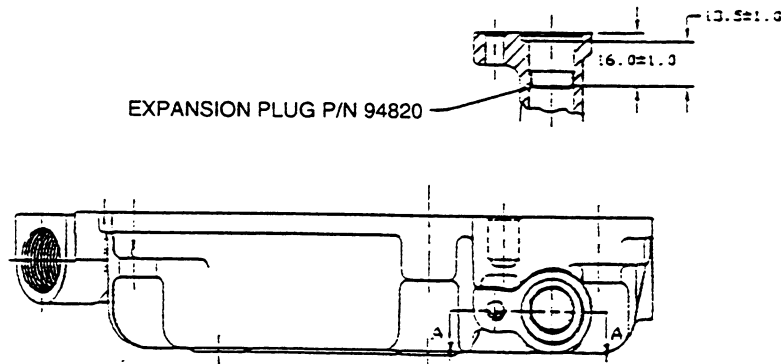
PROBLEM: Oil may leak from around the plastic/metal oil fill cover.

CORRECTIVE ACTION: Replace cover with expansion plug Part # 94820.

WARNING: DO NOT EXCEED MAXIMUM DEPTH, PLUG MAY ENTER CRANKCASE.

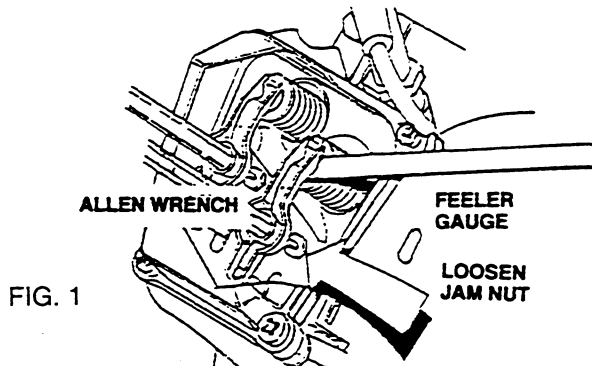
FIG. 1

**PROBLEM:** There may be some push rods in the field with "soft" tips that wear prematurely causing hard starting, poor performance, excessive valve lash/play, no compression release, broken valve retainers.

- B) Replace rod or rods if needed and adjust valve lash:
- 1) Piston at TDC of compression stroke (both valve fully closed)
  - 2) Jam nut must be loose. (Fig. 1)
  - 3) Use an allen wrench (8mm for GN190, GN191 and GN220; and 10mm for GN320 and GN360) to turn the pivot ball stud while checking clearance between rocker arm and valve stem with a feeler gauge. (The proper clearance is 0.05 - 0.1 mm for all models).
  - 4) When the clearance is correct hold pivot stud with the allen wrench and tighten jam nut (Fig. 2) to (6.3 ft. lbs. for the GN190, GN191, and GN220) or (14.5 ft. lbs. for the GN320 and GN360).
  - 5) After tightening jam nut recheck valve clearance to make sure it did not change.
