# **GENERAC**<sup>®</sup>

**P**RODUCT **I**NFORMATION **B**ULLETINS,

**P**ARTS **U**PDATE **B**ULLETINS &

**W**ARRANTY **I**NFORMATION **B**ULLETINS

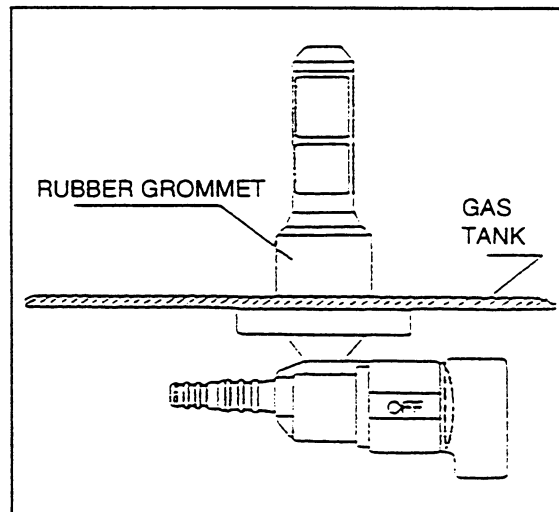
FIGURE 2

**PROBLEM:** Over insertion of the fuel shut-off valve into the rubber grommet can cause elongation of the fuel outlet on the tank. The fuel shut-off valve has a stop built into it, but we have seen the fuel shut-off valve pushed beyond the stop (Figure 1).

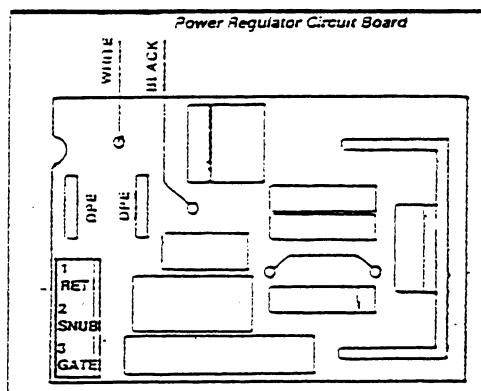
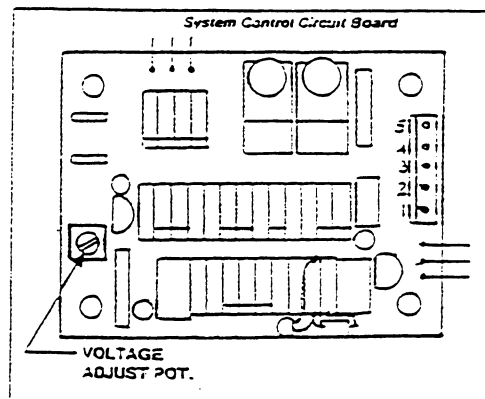
PROBLEM: The A.C. output may be low (50 - 70 V.A.C.) after rewiring the power regulator board and attempting adjustment to the system control board voltage pot.

CORRECTIVE ACTION: To correct this problem switch D.P.E. wires (2 & 6) or (RED AND BLUE) on power regulator board.

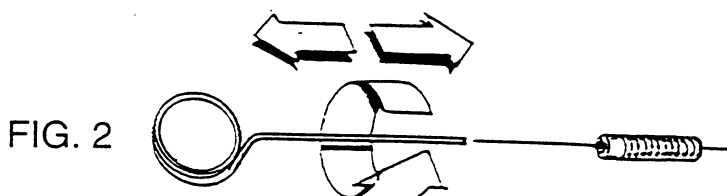
- DATE: April 1995
- SUBJECT: Restricted Nozzle
- PROBLEM: A clogged nozzle may cause excessive pump pressure. A partially clogged nozzle can cause pulsating or poor performance.
- CORRECTIVE ACTION: If the nozzle becomes clogged, immediately clean the nozzle.
- 1) Shut unit off, disconnect the power supply (electric) and water supply.
  - 2) Separate the wand from the gun.
  - 3) Remove the nozzle using a 5/64 or 2mm hex key. (Fig. 1)
  - 4) Use a wire (paper clip works great) to free any foreign materials clogging the nozzle (Fig. 2).
  - 5) Use water supply to backflush the wand. (Fig. 3)
  - 6) Reinstall nozzle into gun.
  - 7) Reconnect wand to the gun.
  - 8) Reconnect water supply.
  - 9) Operate unit, if pulsing persists repeat steps 1 through 8.

INSERT WIRE INTO NOZZLE AND TURN BACK AND FORTH TO CLEAR OBSTRUCTION.

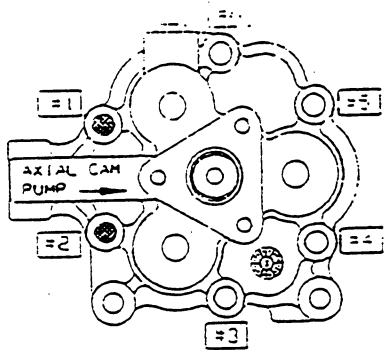
FIG. 1

PROBLEM: The first 600 Generac pump pressure washers utilize 2 bolts (70mm long) that are 5mm shorter than the other 4 bolts (75mm long).

CORRECTIVE ACTION: These bolts cannot be interchanged, this will cause damage to the pump. Utilizing Fig. 1 and Fig. 2 below ensure that the bolts are replaced correctly. The 2 - 70mm headbolts go into position #1 and #2, the other 4-75mm headbolts go into position #3 - #4 - #5 - #6. Torque to 18 ft. lbs.

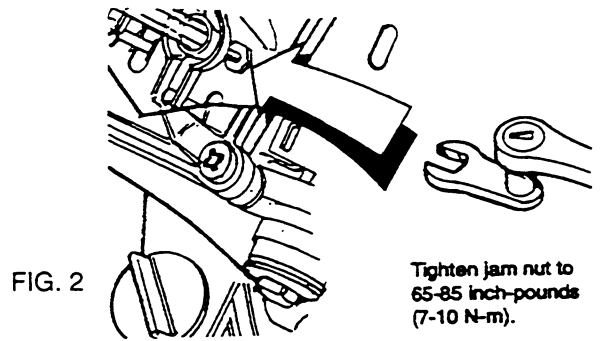
FIG. 2

**PROBLEM:** There may be some push rods in the field with "soft" tips that wear prematurely causing hard starting, poor performance, excessive valve lash/play, no compression release, broken valve retainers.

- B) Replace rod or rods if needed and adjust valve lash:
- 1) Piston at TDC of compression stroke (both valve fully closed)
  - 2) Jam nut must be loose. (Fig. 1)
  - 3) Use an allen wrench (8mm for GN190, GN191 and GN220; and 10mm for GN320 and GN360) to turn the pivot ball stud while checking clearance between rocker arm and valve stem with a feeler gauge. (The proper clearance is 0.05 - 0.1 mm for all models).
  - 4) When the clearance is correct hold pivot stud with the allen wrench and tighten jam nut (Fig. 2) to (6.3 ft. lbs. for the GN190, GN191, and GN220) or (14.5 ft. lbs. for the GN320 and GN360).
  - 5) After tightening jam nut recheck valve clearance to make sure it did not change.

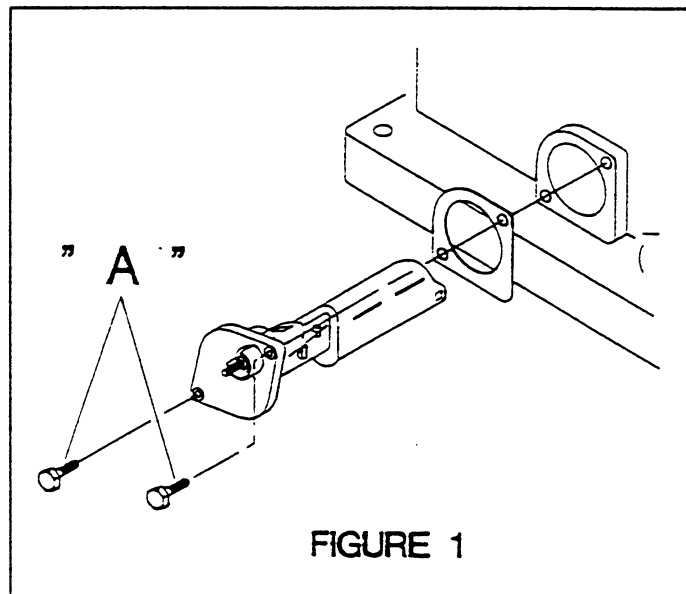
PROBLEM: The taptite screws used to hold the LOS module to the engine may strip causing loss of oil due to improper sealing.

CORRECTIVE ACTION: Replace the original taptite (See figure 1 item "A") Part # 32713 #10-32 x 5/8" with part # 24679 # 10-32 x 3/4".

A) Remove one taptite (Fig. 1 Item "A") and replace. Remove other taptite and replace it. (Torque screws 35 to 45 in. Lbs.)

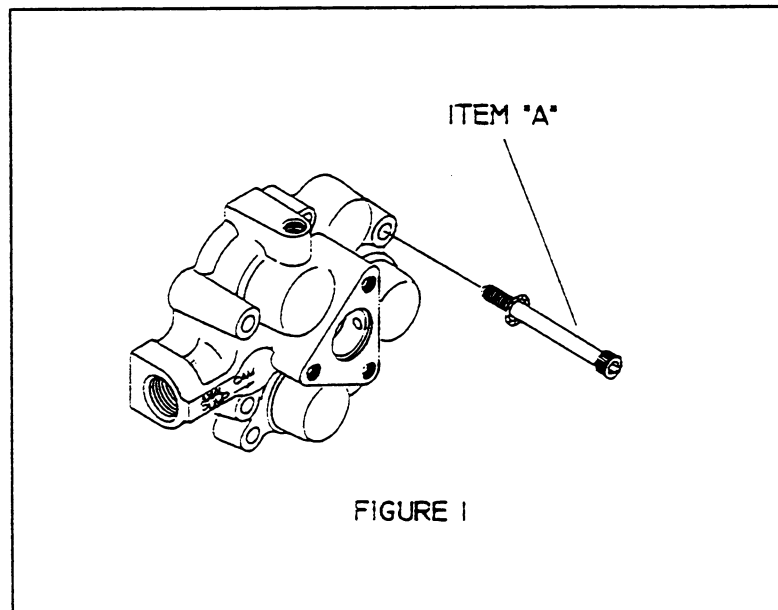
PROBLEM: After installation and torquing the stainless steel head bolts (Fig. 1, Item "A") some were found to have stretched slightly.

CORRECTIVE ACTION: Units in the field will not be affected by this unless repairs are needed to the head assembly area. If these bolts are removed measure them to confirm length of 75mm. If the bolt is longer replace with part number #93874 M8-1.25 x 75mm which will be grade 8 steel (Metric 10.9) and torque to 18ft. LBS in a criss-cross pattern.

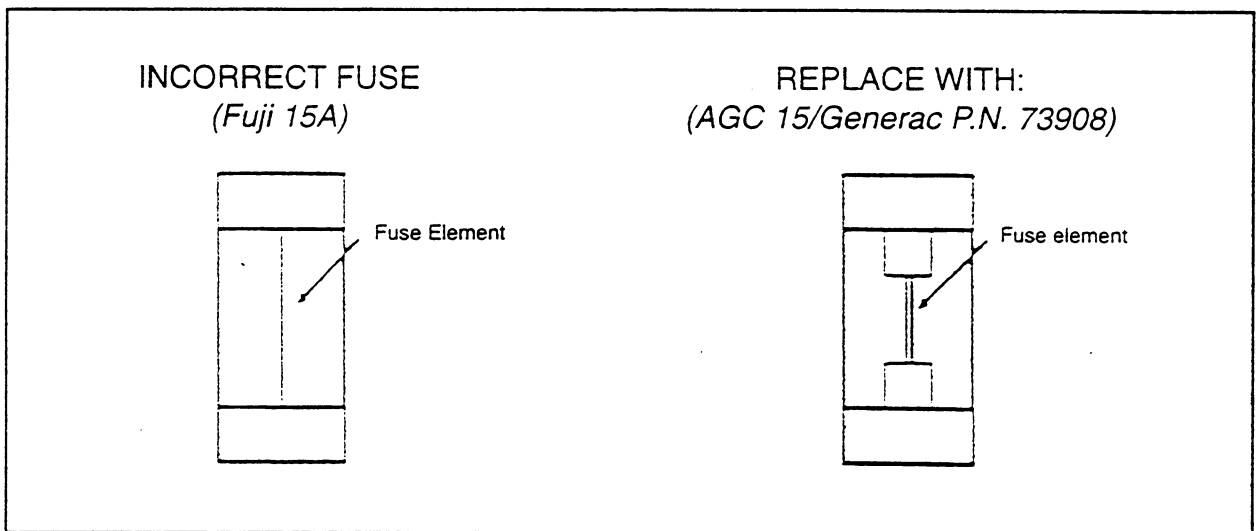
CORRECTIVE ACTION: If one of the above units is brought in for service, check the 15A input fuse on the control panel. There is a possibility that this fuse may be too short for the fuse holder. If this fuse is inscribed with "Fuji/15A," replace it with an AGC 15A fuse, Generac part no. 73908.

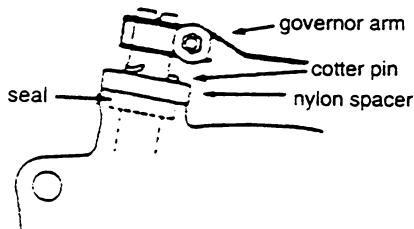
#### SEAL REPLACEMENT INSTRUCTIONS

**PROBLEM:** If you notice or receive a customer complaint of oil stain on sheet metal in the area under the carburetor, the governor shaft seal may have been damaged during installation. If inspection indicates that seal replacement is called for, order seal kit # 68554A. The kit will include seal and cotter pin.

- 1) Locate and remove governor arm, remove and discard cotter pin, and remove nylon spacer.
- 2) The seal may now be removed, using a small seal puller or screwdriver. Taking care not to scratch the governor shaft, slowly roc the seal out of the cylinder block.
- 3) When installing the new seal, take care not to cut it on the sharp edge of the shaft! If necessary, chamfer end of shaft with a file to prevent seal damage.
- 4) After reassembly, you must perform static governor adjustment as follows:

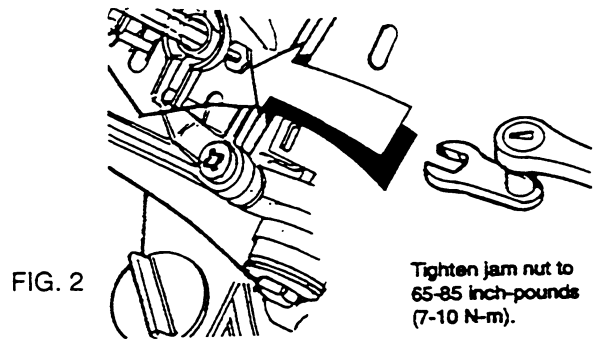
FIG. 2

**PROBLEM:** There may be some push rods in the field with "soft" tips that wear prematurely causing hard starting, poor performance, excessive valve lash/play, no compression release, broken valve retainers.

**CORRECTIVE ACTION:** Replace push rods that appear to be prematurely worn. Part # 88396A for GN190, 191, 220. Part # 88396B for GN320, 360.

- B) Replace rod or rods if needed and adjust valve lash:
- 1) Piston at TDC of compression stroke (both valve fully closed)
  - 2) Jam nut must be loose. (Fig. 1)
  - 3) Use an allen wrench (8mm for GN190, GN191 and GN220; and 10mm for GN320 and GN360) to turn the pivot ball stud while checking clearance between rocker arm and valve stem with a feeler gauge. (The proper clearance is 0.05 - 0.1 mm for all models).
  - 4) When the clearance is correct hold pivot stud with the allen wrench and tighten jam nut (Fig. 2) to (6.3 ft. lbs. for the GN190, GN191, and GN220) or (14.5 ft. lbs. for the GN320 and GN360).
  - 5) After tightening jam nut recheck valve clearance to make sure it did not change.

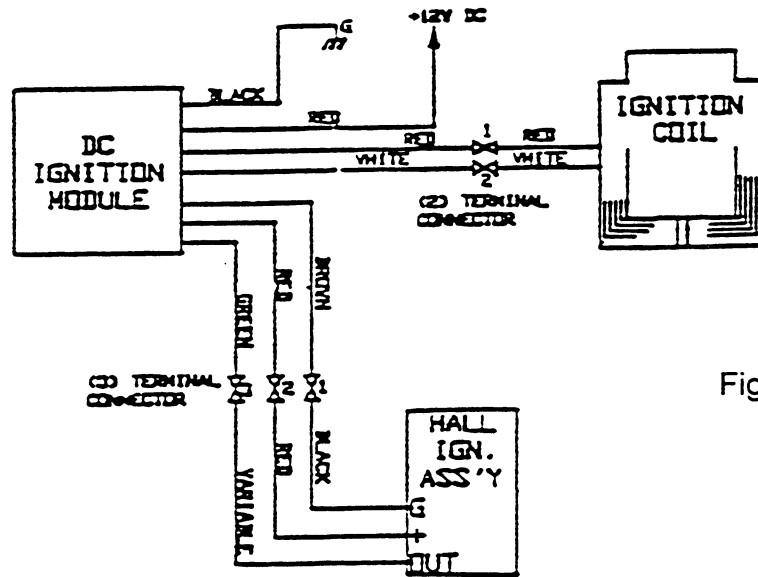
Figure 1

- C. Connect one VOM test lead to the white wire connector pin.
  - D. Connect the other VOM test lead into the spark plug rubber boot so it contacts the leads metal terminal end. The VOM should measure 16,000-17,000 ohms. (16.0-17.0 k-ohms).

4. If readings are within specs and no spark occurred in BY-PASSING THE IGNITION SENSOR above, the ignition module is defective.

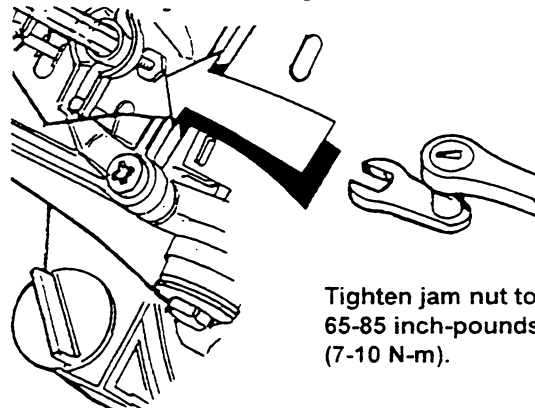
**CORRECTIVE ACTION:** When adjusting the valve clearance, the engine should be at room temperature and the piston should be at top dead center of it's compression stroke (both valves closed). Correct clearance is 0.05 - 0.1mm. Replacement of head gaskets is suggested. The GN190 takes a #77167, the 191, and 220 engines take a #88397; 320, 360, and 410 engines take a #71987 head gasket. Adjust the valve as follows:

1. Loosen the rocker arm jam nut. Use an allen wrench to turn the pivot ball stud while checking the clearance between the rocker arm and the valve stem with a feeler gauge.

2. When the valve clearance is correct, hold the pivot ball stud with the allen wrench (8mm or 10mm depending on the engine) and tighten the rocker arm jam nut with a 10mm crows foot. Tighten the jam nut to 65-85 inch lbs. torque. After tightening the jam nut, recheck the valve clearance to make sure clearance did not change.

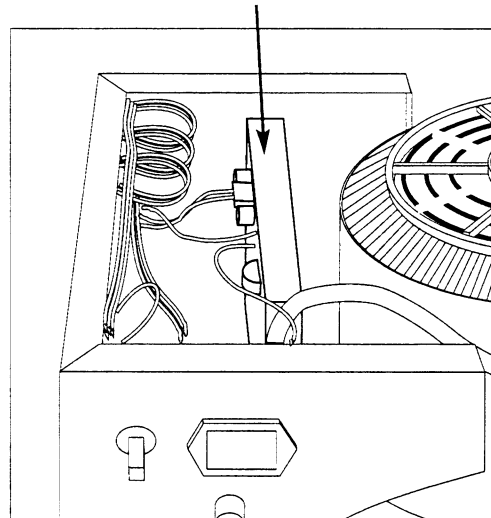
**CCG Control Circuit Board**

**SYMPTOM:** Sudden drop in engine speed resulting in a low voltage condition, followed by engine shutdown. The predominant symptom is a problem with starting and running the coach roof air conditioner.

**VERIFYING A DEFECTIVE BOARD:** If a unit is one of the three models within the serial number range listed above, check the date code printed in white on the edge of the circuit board. **The affected date code range is 9752 through 9807.**

**CORRECTIVE ACTION:** If the circuit board code is within the affected range, it must be replaced. If the replacement circuit board is from your current stock, ensure that its date code is not within the affected range.

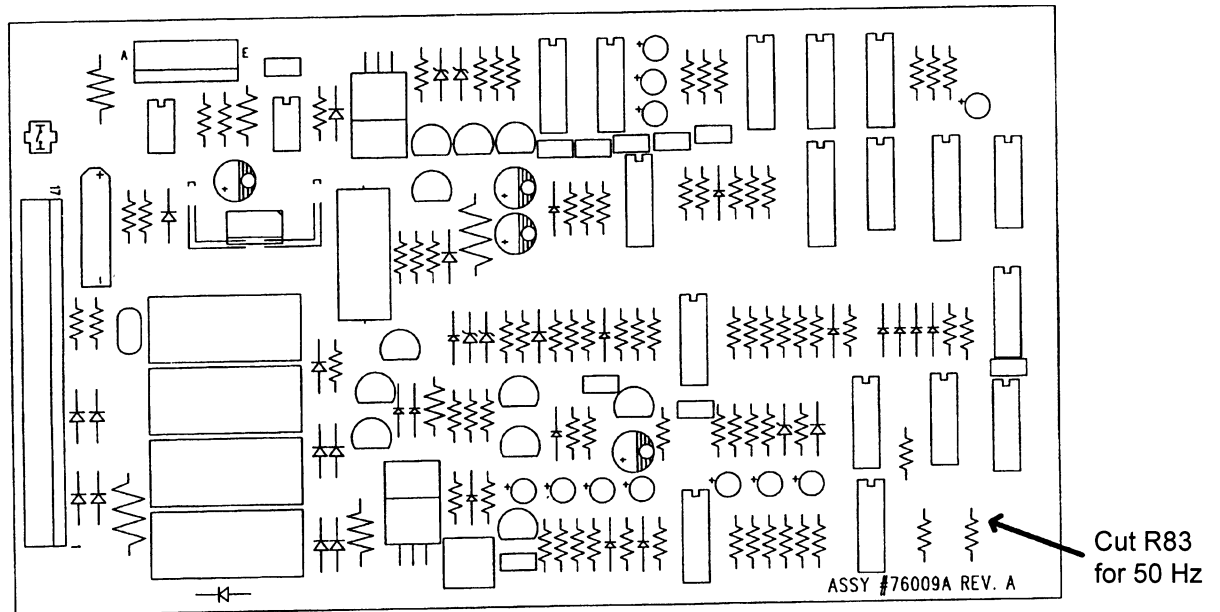
**PCB Part Number 76009A**

The new PCB was designed to be compatible with 60 Hz or 50 Hz applications. Because of this change, service replacement 76009A PCB's used in a 50 Hz application will need the R83 resistor cut for proper weekly exercise timer operation (see diagram below). For 60 Hz applications, the R83 resistor must be left intact.
